***NPDES
Inspection Report***

***BMC West Truss & Components
Everett, WA***

***April 29th, 2016
May 10th, 2016***

***Brian Levo
Environmental Protection Agency, Region 10
Office of Compliance and Enforcement
Inspection and Enforcement Management Unit***

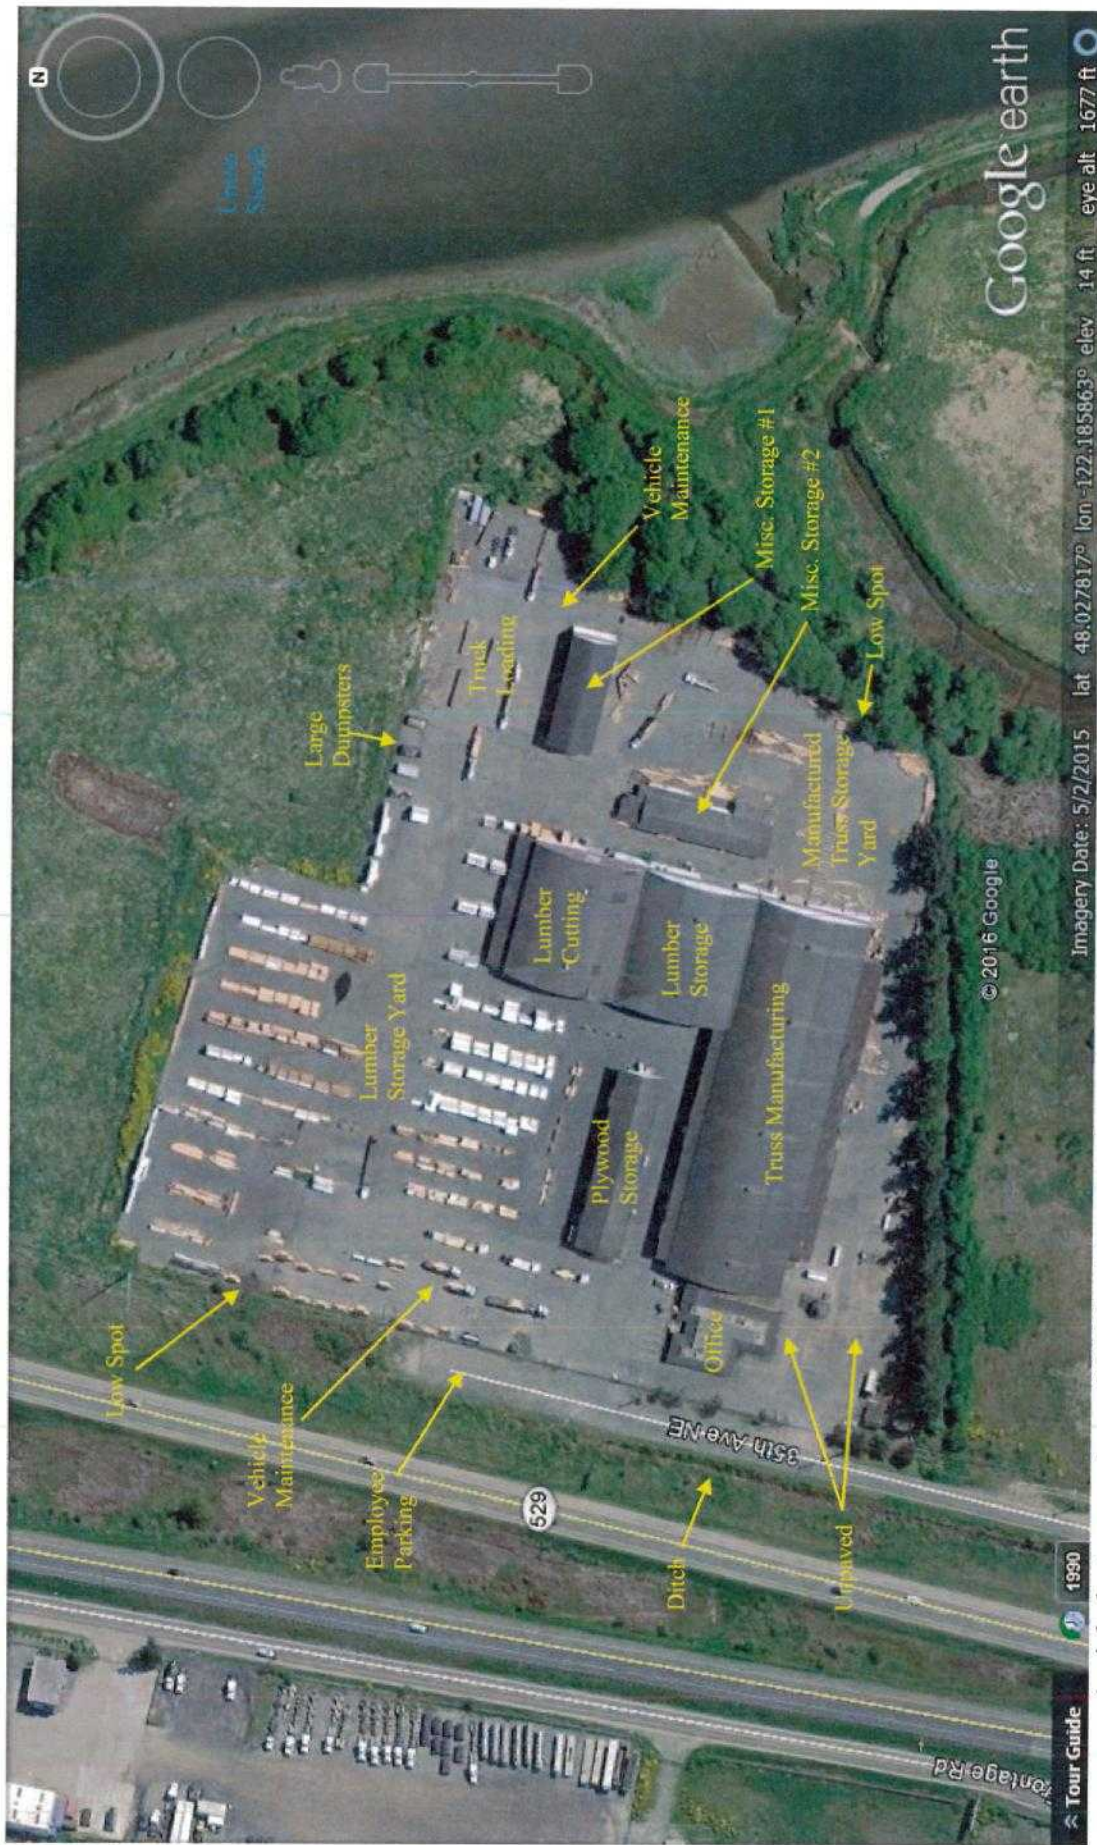
- Pollution Prevention Team – Mr. Waldron said that the names listed on the team were no longer current.
- Site Map – Displayed building and catch basin location information but was missing many of the details required by the permit (**Photo 1, Attachment B**).

Aerial photo overview of BMC with approximate infrastructure locations shown in yellow.

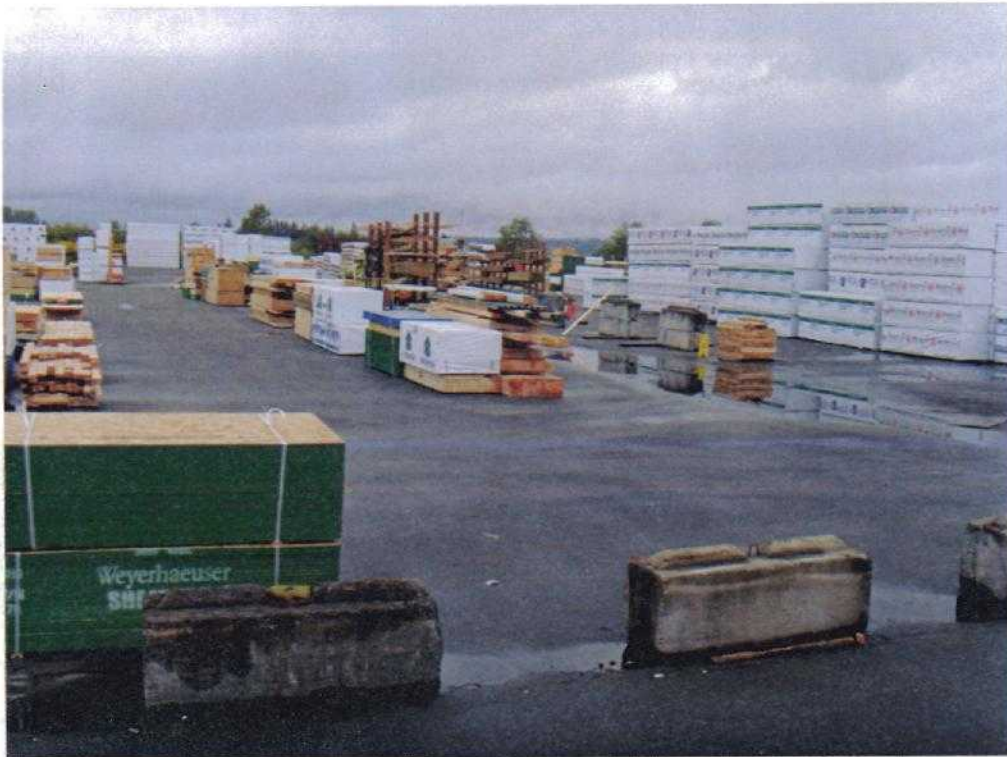
Photo 2 (SI850487): Northern view of the lumber storage yard from the plywood storage building.

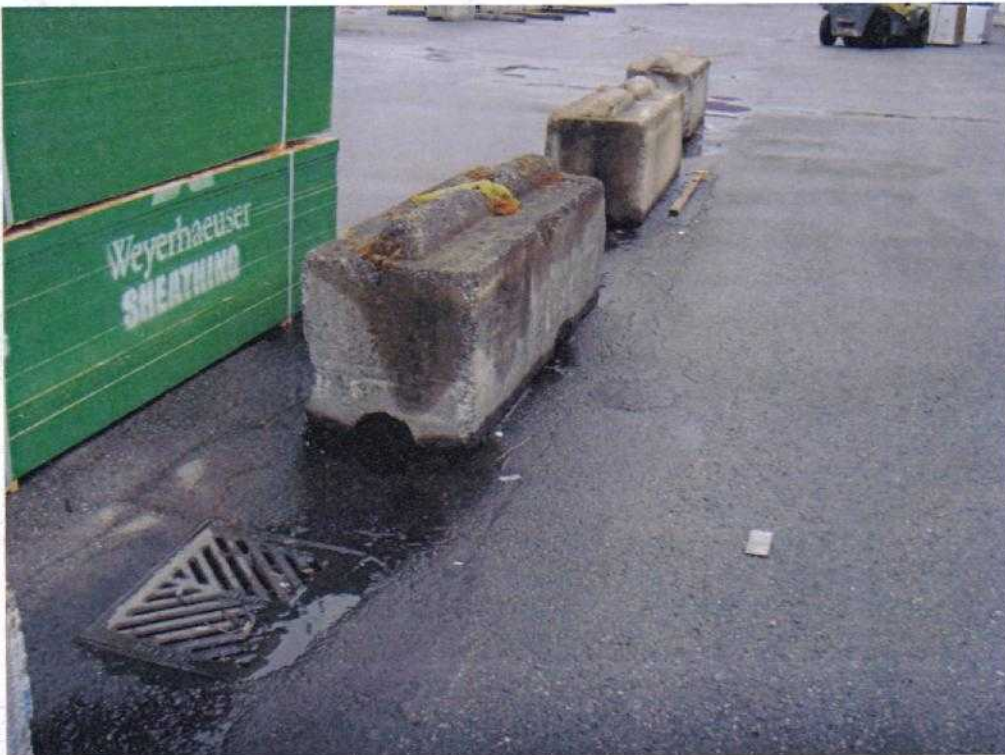
I noted that none of the BMC catch basins had filter inserts installed on 4/29/16. Mr. Waldron said that the filter inserts are supplied by Grainger, and that they are replaced every three to four months, but they had just been removed sometime on 4/18/16 or 4/20/16, and had not been replaced yet. During my follow-up inspection on 5/10/16 filter inserts were installed in catch basins #02, #03, #04, and #05 (**Photo 8**). Mr. Waldron showed me the filter insert packaging and provided me a product sheet that had been included in the packaging (**Attachment C**). The filter inserts were an Ultra-DrainGuard Oil & Sediment Plus Model.

Photo 3 (SI850482): Storm drain #04 to the north of the plywood storage building. Note that no stormwater filter inserts were installed in this drain on 4/29/16.

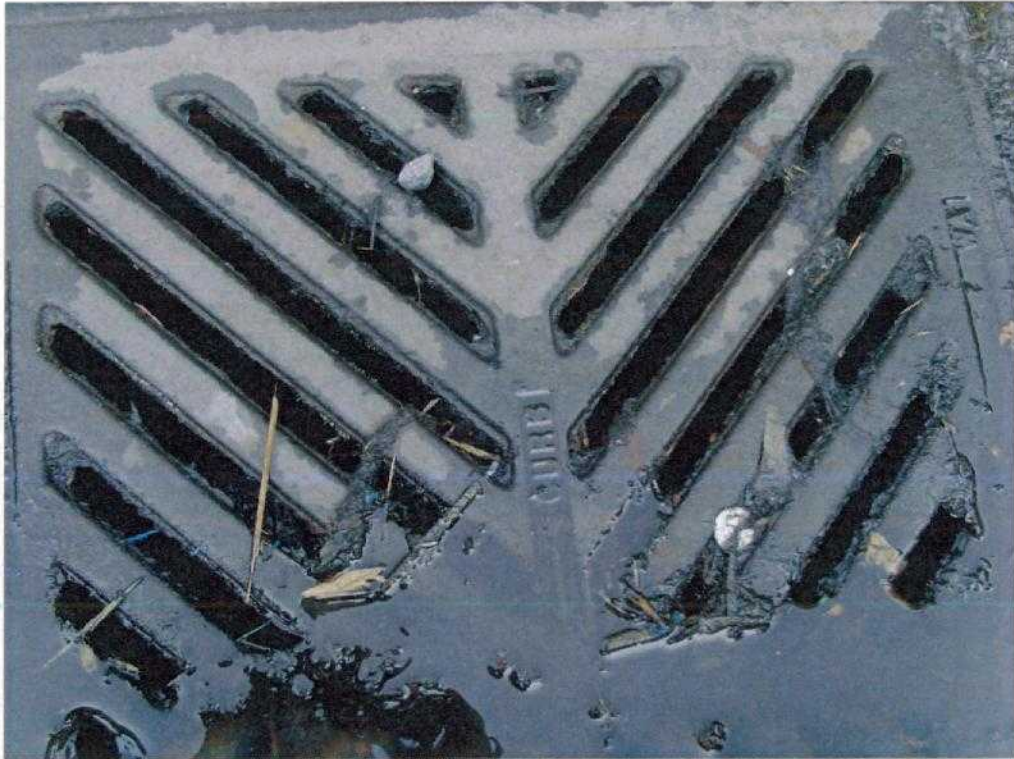
Photo 4 (SI850483): Storm drain #04 to the north of the plywood storage building. Note that no stormwater filter inserts were installed in this drain on 4/29/16.

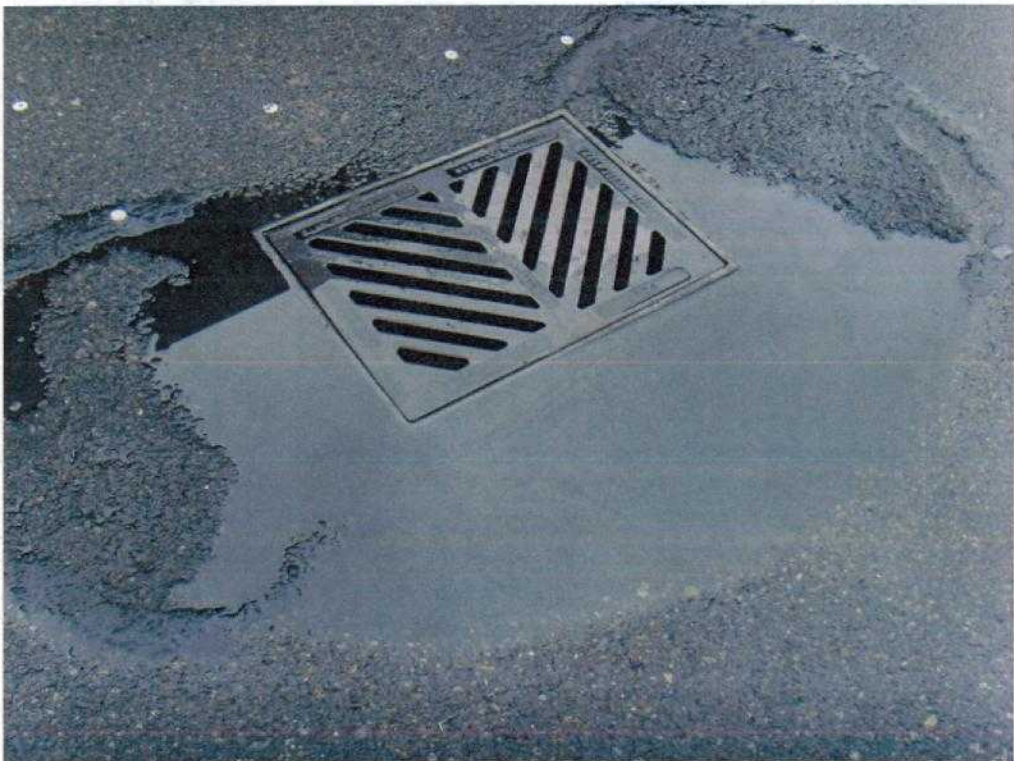
At the time of the 4/29/16 inspection, there was sheen on the stormwater entering catch basin #03 (**Photo 5**) and sheen on the pavement in proximity to catch basin #05 (**Photo 7**). I noted additional sheen in two other areas on the north side of the lumber yard during the 4/29/16 inspection (**Photos 17 & 18**). Mr. Langlois said that employees did not implement spill response BMPs to address small spots of sheen such as these.

As is described in detail in the Facility Review section of this report, there was oil sheen noted in multiple locations at the facility during the 4/29/16 inspection (**Photos 5, 7, 14, 17, 18, and 19**). Mr. Langlois said that employees did not implement spill response BMPs to address small spots of sheen such as these.

Oil leak BMPs were not being implemented at the time of the 4/29/16 inspection.

Photo 5 (SI850485): Storm drain #03 to the north of the plywood storage building. Note that a sheen was flowing into the drain and that no stormwater filter inserts were installed in this drain on 4/29/16.

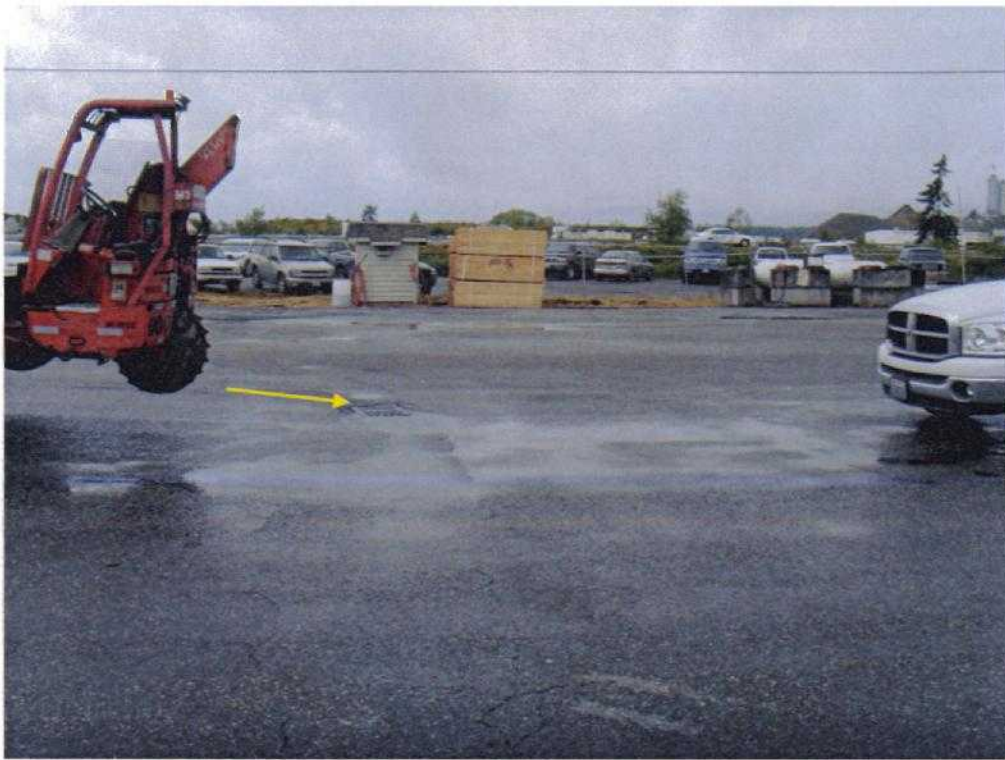
Photo 6 (SI850481): Storm drain #05 (yellow arrow) to the northwest of the plywood storage building.

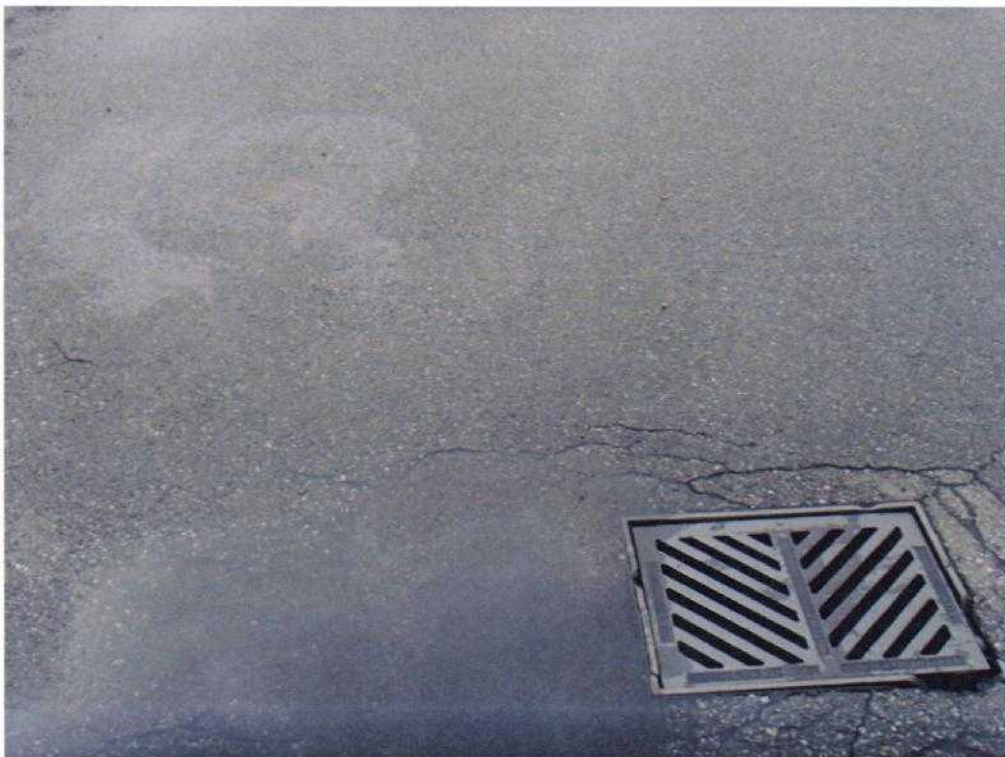
Photo 7 (SI850488): Storm drain #05 to the northwest of the plywood storage building. Note the sheen in proximity to the drain and that no stormwater filter inserts were installed in this drain on 4/29/16.

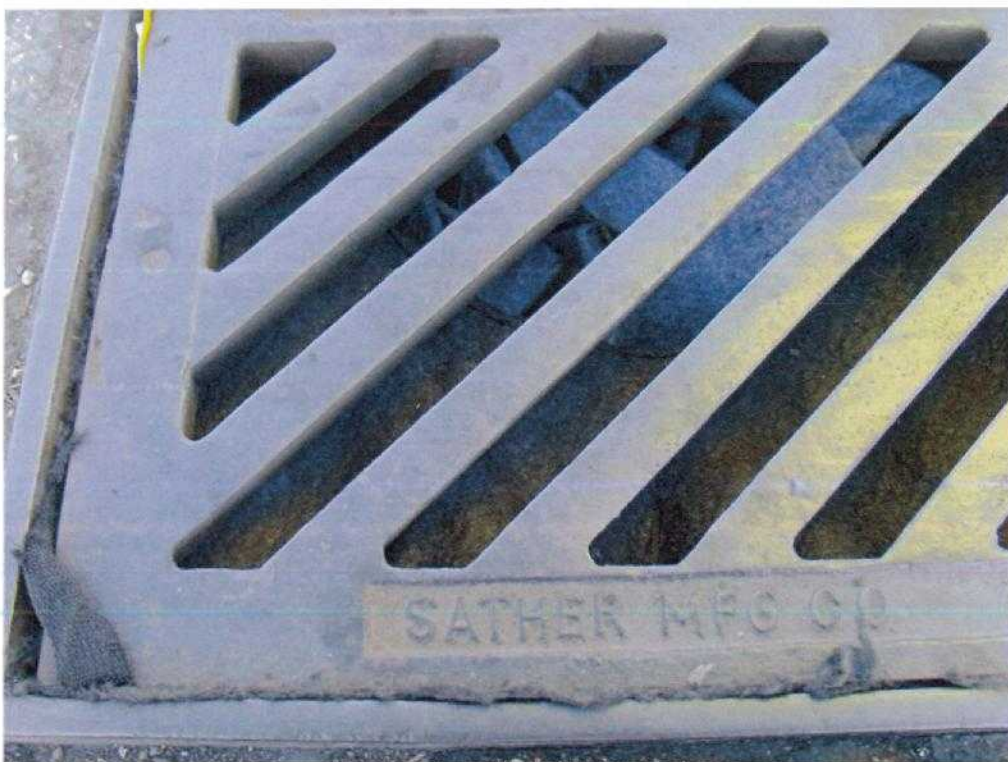
Photo 8 (SI850540): View of the filter inserts inside storm drain #05. This photo was taken on 5/10/16.

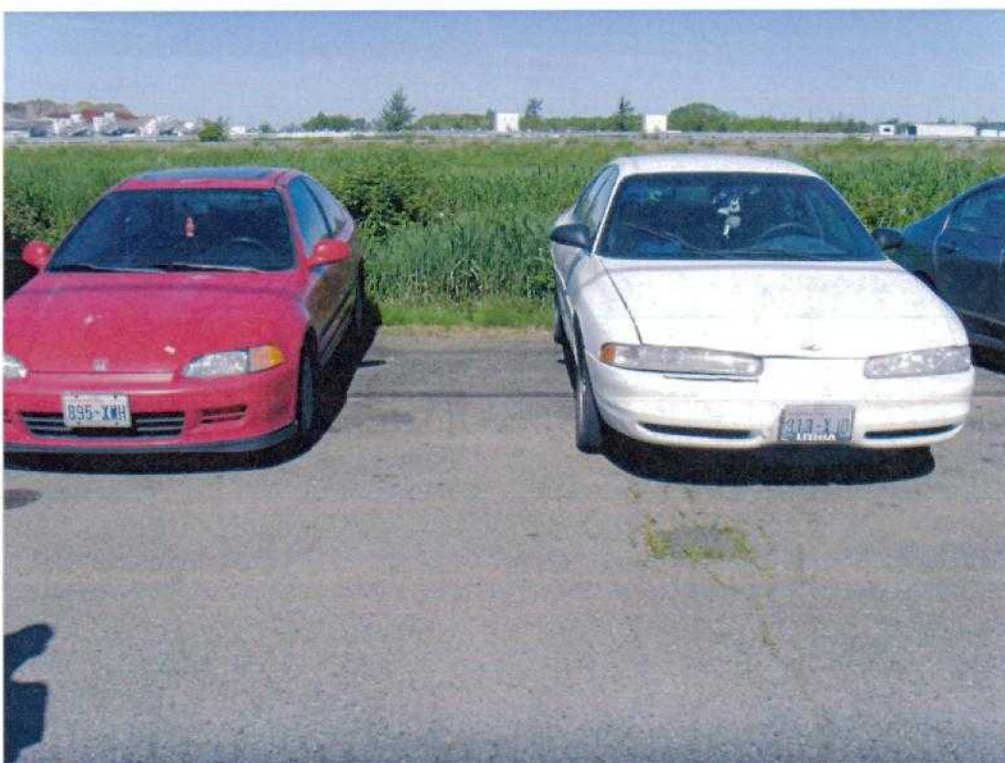
Photo 9 (SI850549): Western view of the ditch along the west side of the employee parking area.

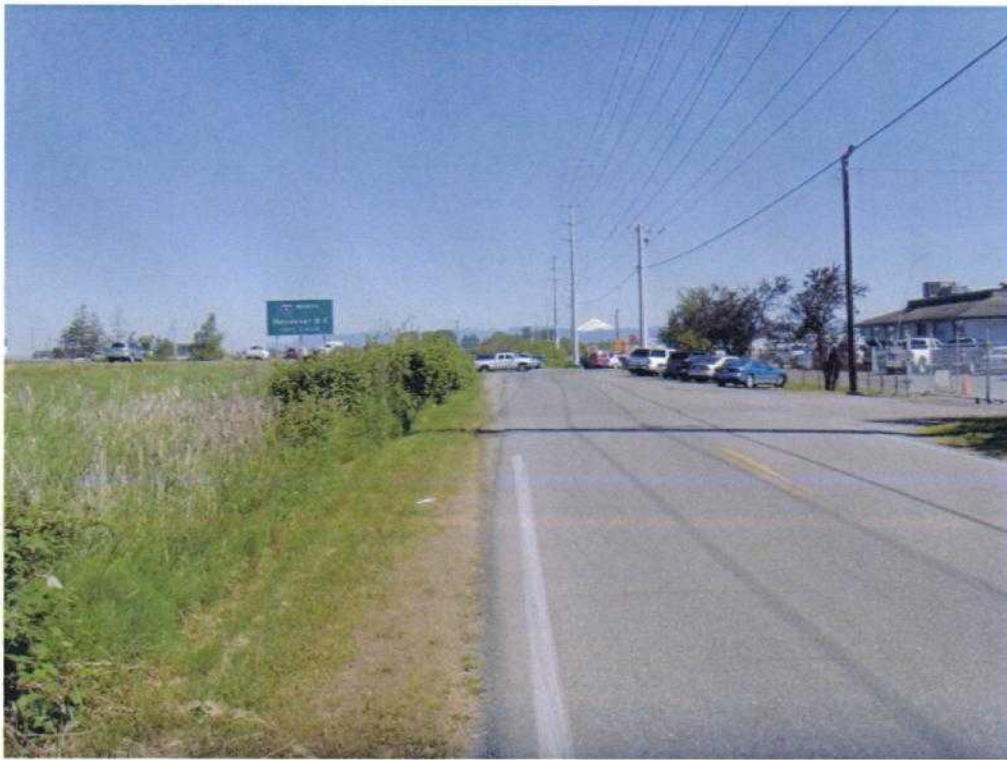
Photo 10 (SI850551): Northern view of the ditch that runs along the west side of the property. Taken from 35th Ave NE south of the entrance to the facility.

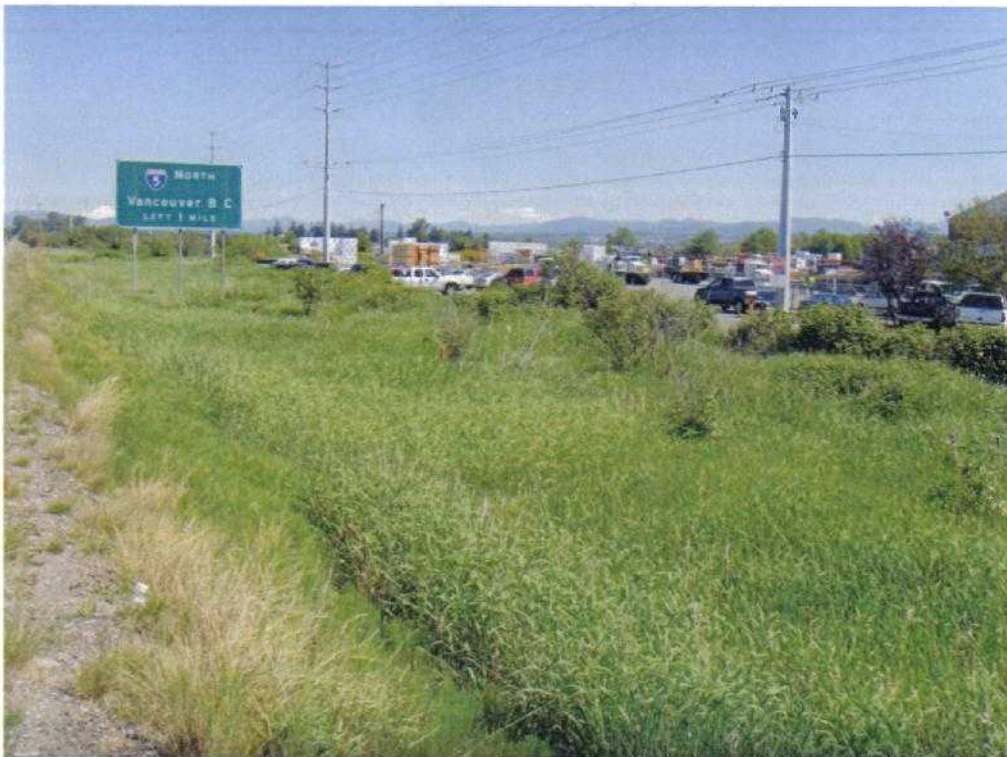
Photo 11 (SI850552): Northeastern view of the ditch that runs along the west side of the property. Taken from Hwy 529 directly west of the facility's employee parking area.

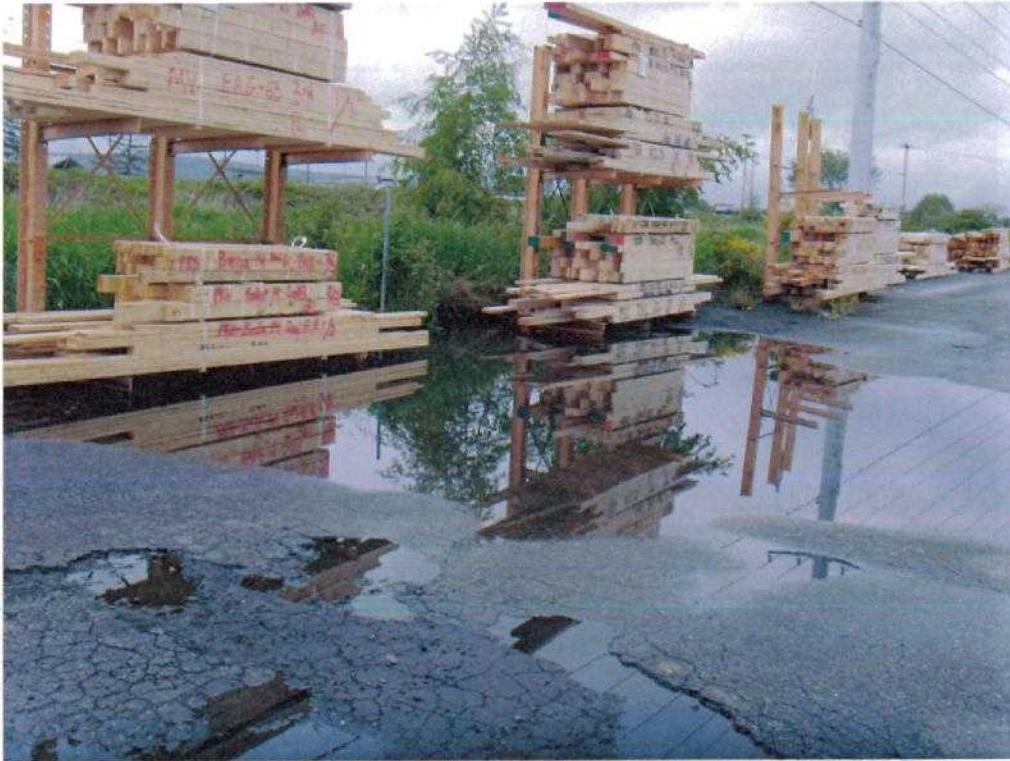
Near the northwest corner of the lumber yard was a low spot. At the time of the 4/29/16 inspection, a pool of water extending over 100 ft. into the lumber yard was present (**Photos 12-15**). According to both Mr. Langlois and Mr. Waldron, this pooling was caused by run-on water from the ditch, and they said that it commonly happened when there was a hard rain. Neither of them could specify the exact frequency that this occurs or how much rainfall is necessary to cause run-on to happen. I observed a forklift drive through the pooled water during my 4/29/16 inspection, and noted that there was sheen on the water surface (**Photo 14**). Mr. Langlois said that the run-on water may be tidally influenced from Union Slough, but Mr. Waldron said that he suspected run-off from Hwy 529 was the source of the water. Mr. Tickle said that the BMC property was built on pavement which capped fill material from historic dredging of the surrounding sloughs, and overtime the ground beneath some of the paved areas sank.

At the time of the 4/29/16 inspection, a pool of water extending over 100 ft. into the lumber yard was present (**Photos 12-15**). According to both Mr. Langlois and Mr. Waldron, this pooling was caused by run-on water from the ditch along the west side of the property, and they said that it commonly happened when there was a hard rain.

Photo 12 (SI850492): Northern view of the low spot near the northwest corner of the lumber yard.

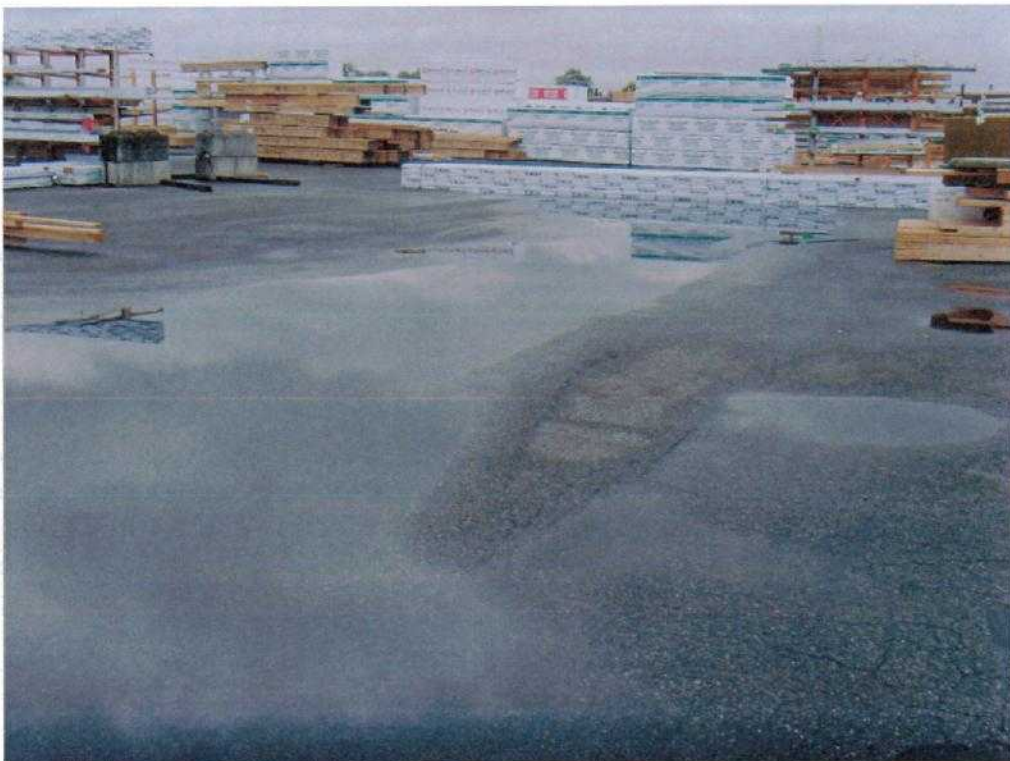
Photo 13 (SI850493): Eastern view of the low spot near the northwest corner of the lumber yard.

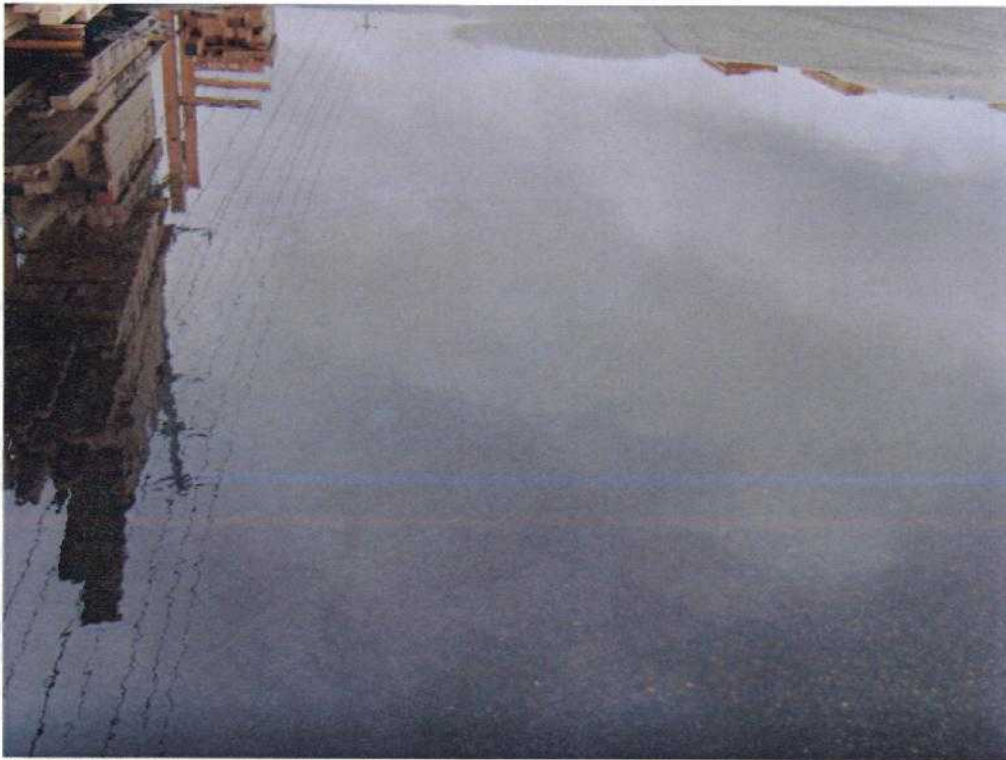
Photo 14 (SI850494): Sheen on the standing water at the low spot near the northwest corner of the lumber yard.

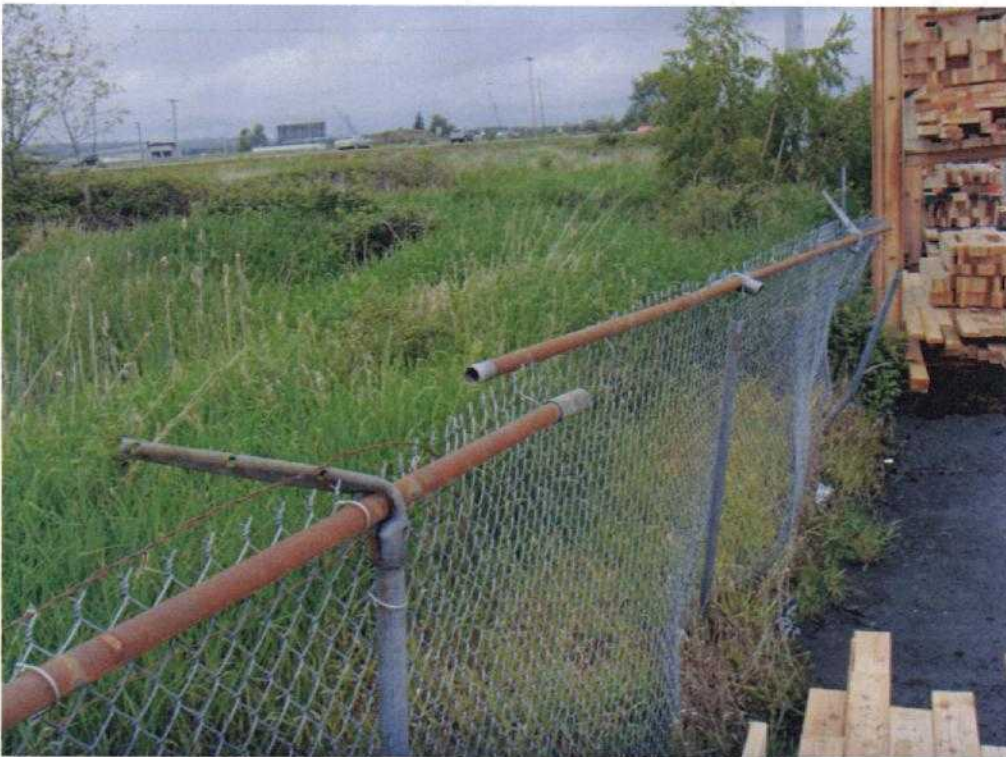
Photo 15 (SI850496): Northern view of the ditch along the northwest side of the lumber yard. This photo was taken from the vicinity of the low spot.

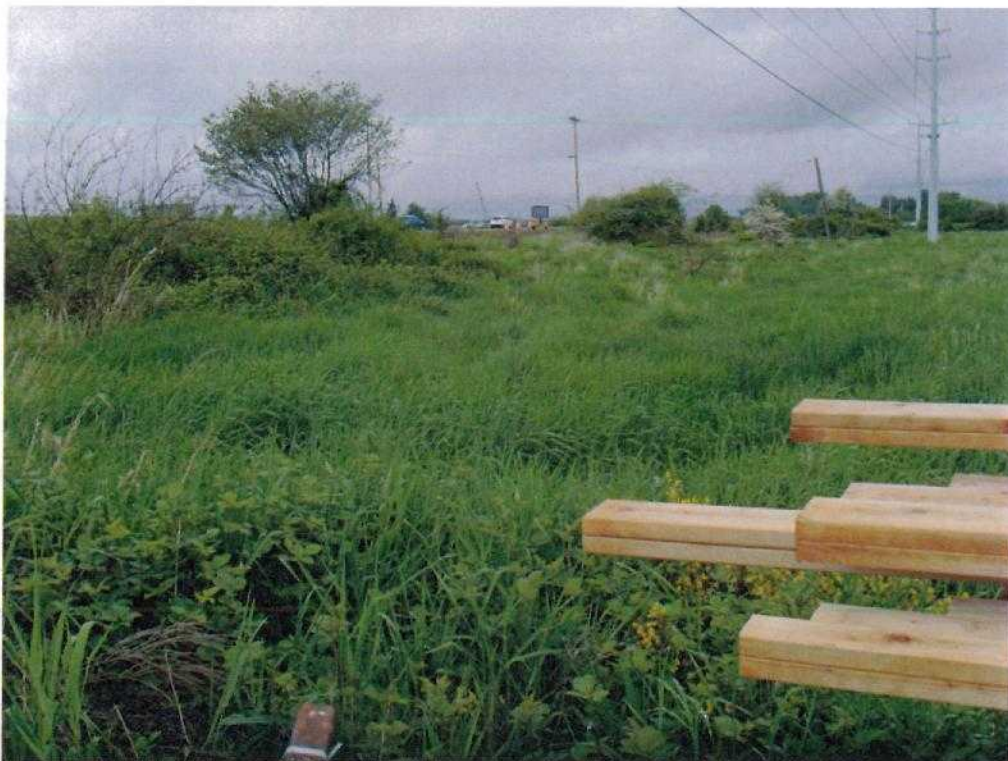
The vegetated area on the north side of the BMC property was flat, thickly vegetated, and the soil was saturated with water during both inspection days (**Photo 16**). Due to the vegetation and the flat contour there was no obvious flow path of stormwater.

Photo 16 (SI850497): Northern view of the ditch from the northwestern most corner of the lumber yard.

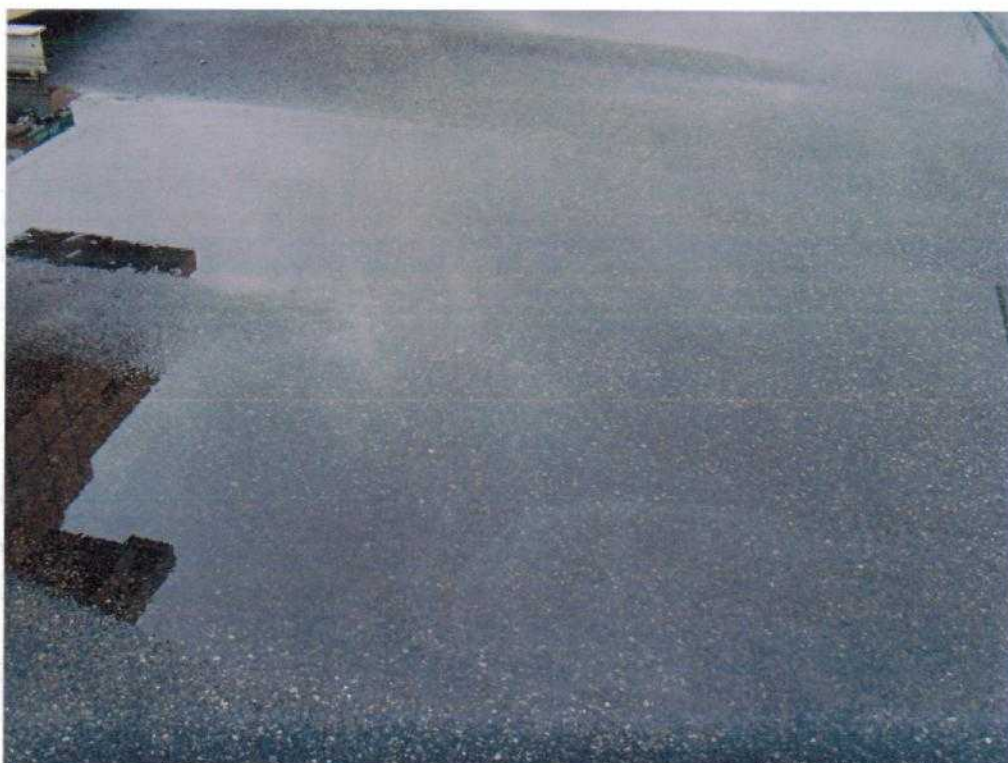
Photo 17 (SI850499): Sheen on the upstream portion of the standing water at the low spot.

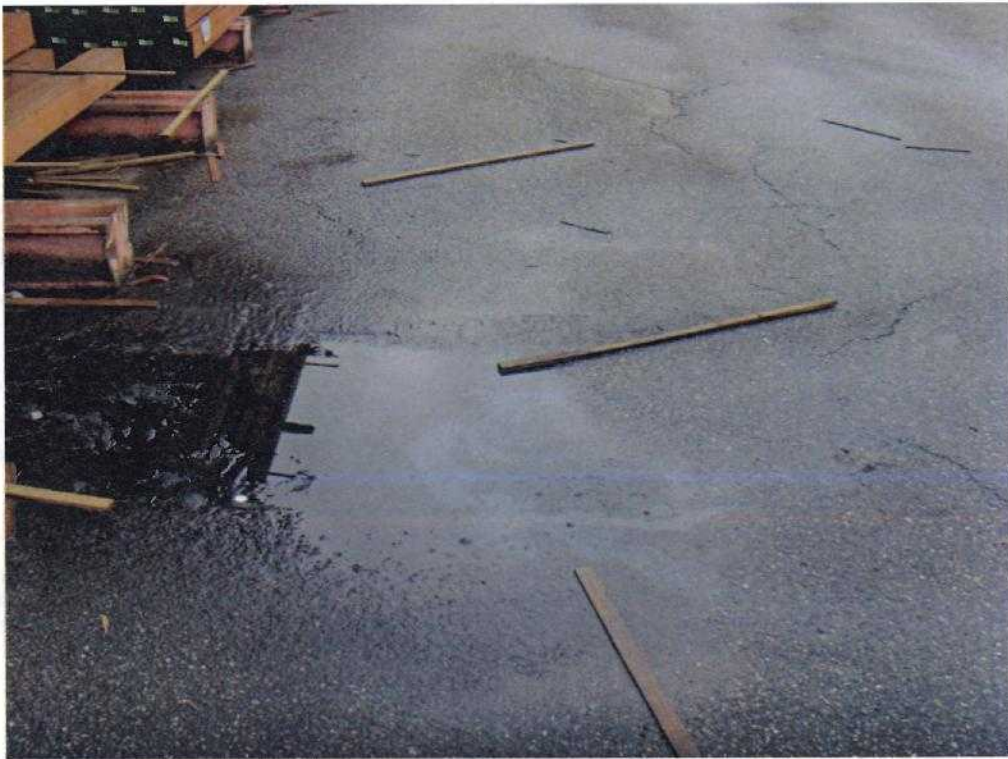
Photo 18 (SI850500): Sheen on the pavement on the north side of the lumber yard.

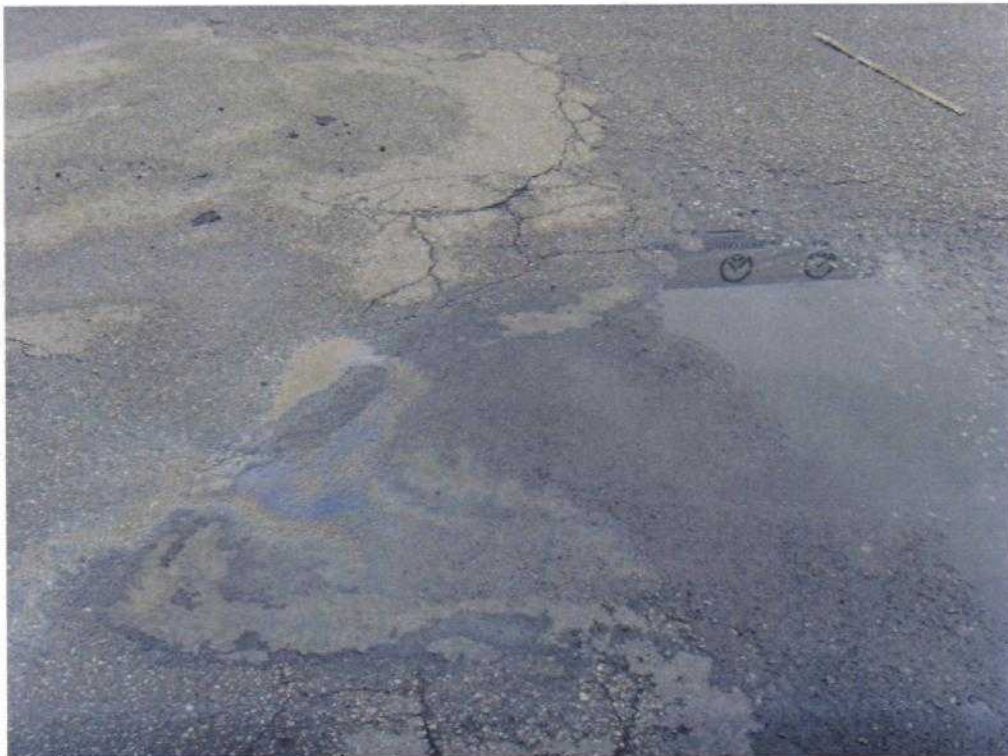
Photo 19 (SI850501): Sheen on the pavement on the north side of the lumber yard.

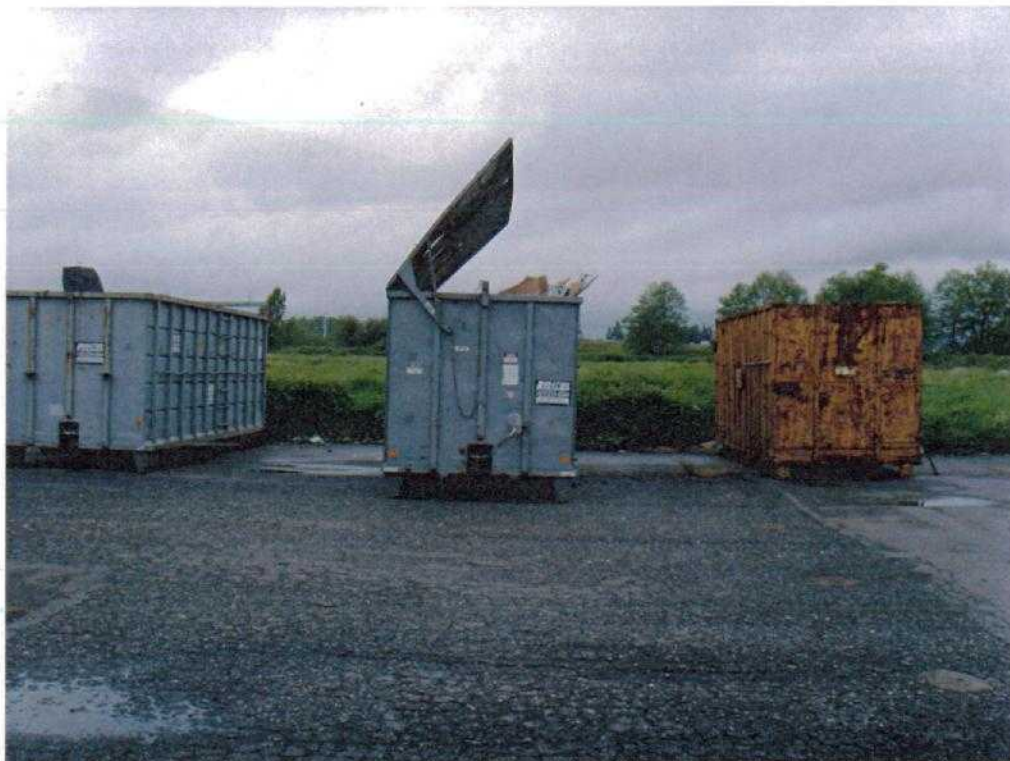
At the time of the 4/29/16 inspection, there were four large dumpsters stored near the truck loading area (**Photos 20 & 21**). Mr. Langlois said that two of them were for garbage, one was for metal scraps, and one was for wood scraps. Only one of the garbage dumpsters had a lid and it was open at the time of the 4/29/16 inspection. Mr. Waldron said that these dumpsters previously had lids. Mr. Langlois said that the wood dumpster is emptied approximately every 2-3 weeks, the garbage dumpsters approximately every week, and the metal scrap dumpster is emptied on an as-needed basis.

Photo 20 (SI850502): Northern view of two garbage dumpsters (grey) and a metal scrap dumpster (orange). Only the middle dumpster had a lid and it was open at the time of the 4/29/16 inspection.

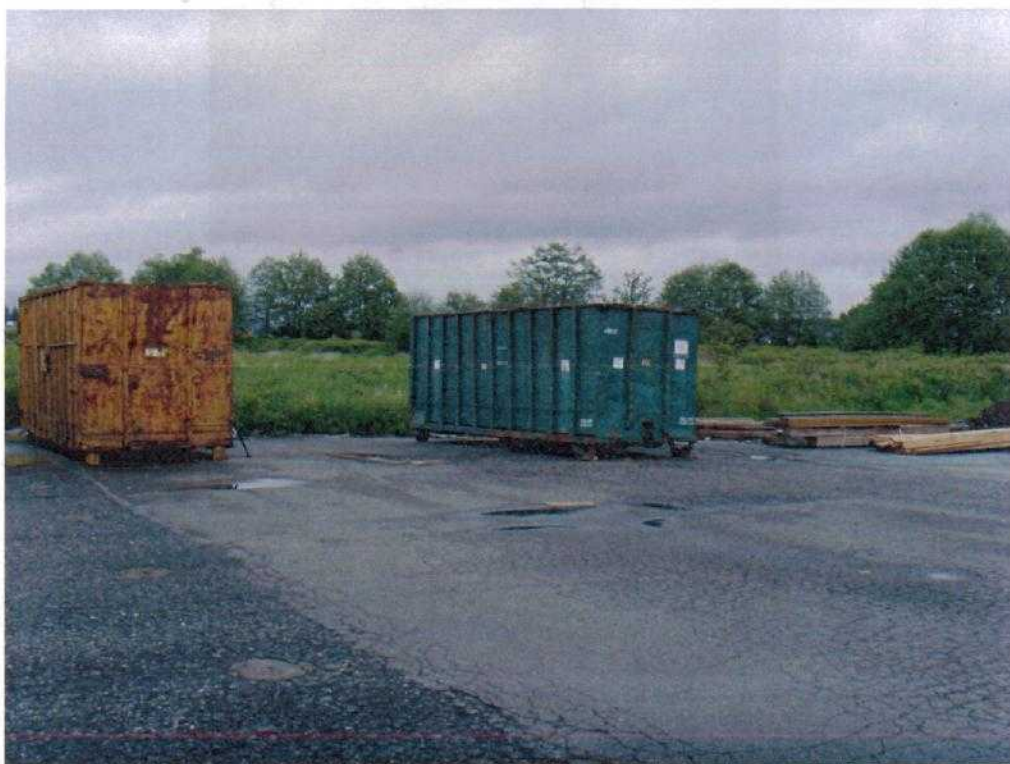
Photo 21 (SI850503): Northeastern view of a metal scrap dumpster (orange) and a wood scrap dumpster (green) without lids.

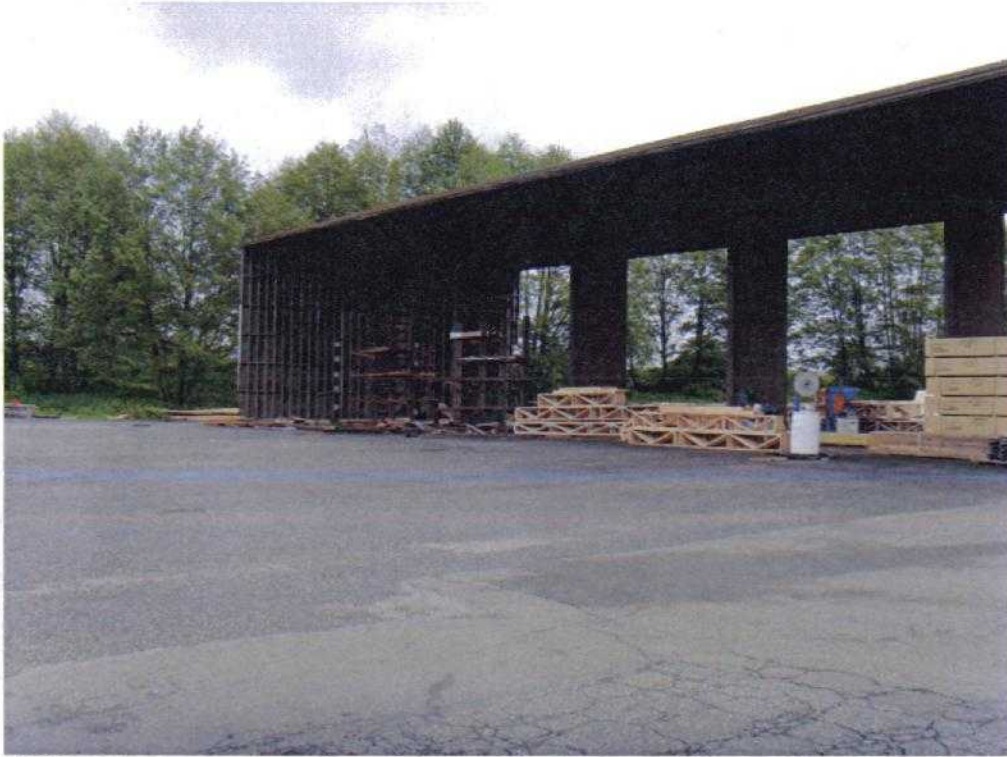
Photo 22 (SI850505): Southeastern view of the truck loading area and miscellaneous storage building #1.

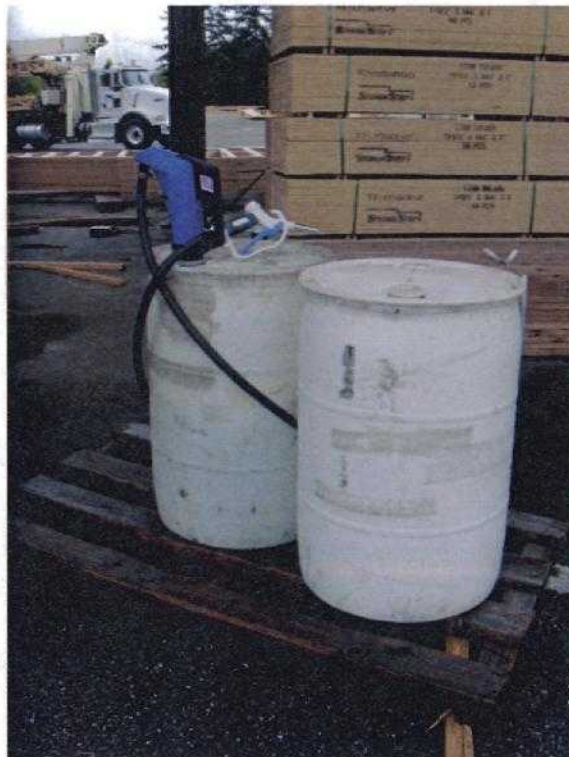
At the time of the 4/29/16 inspection, there were two drums of Blue Def stored without secondary containment (**Photo 23**). Mr. Langlois said that Blue Def is a fuel additive for diesel vehicles to improve the air quality of exhaust. He said that it is added to the semi-trucks in the truck loading area. Mr. Langlois said that one of the drums was empty and the other was partially full.

Photo 23 (SI850507): One partially-full and one empty drum of Blue Def stored under the miscellaneous storage building #1 roof without secondary containment.

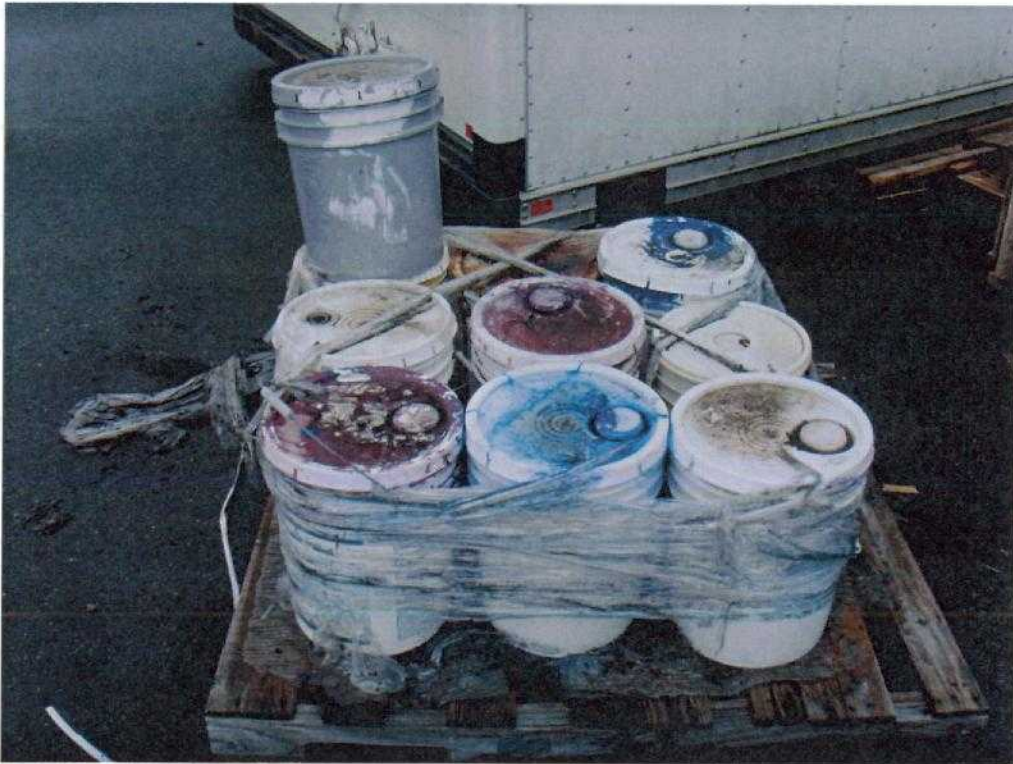
At the time of the 4/29/16 inspection, there were 10 paint cans stored uncovered and without secondary containment at the eastern corner of the truck loading area (**Photo 24**). Mr. Langlois said that they were all partially-full.

Photo 24 (SI850506): 10 partially-full paint cans stored uncovered and without secondary containment at the eastern corner of the truck loading area.

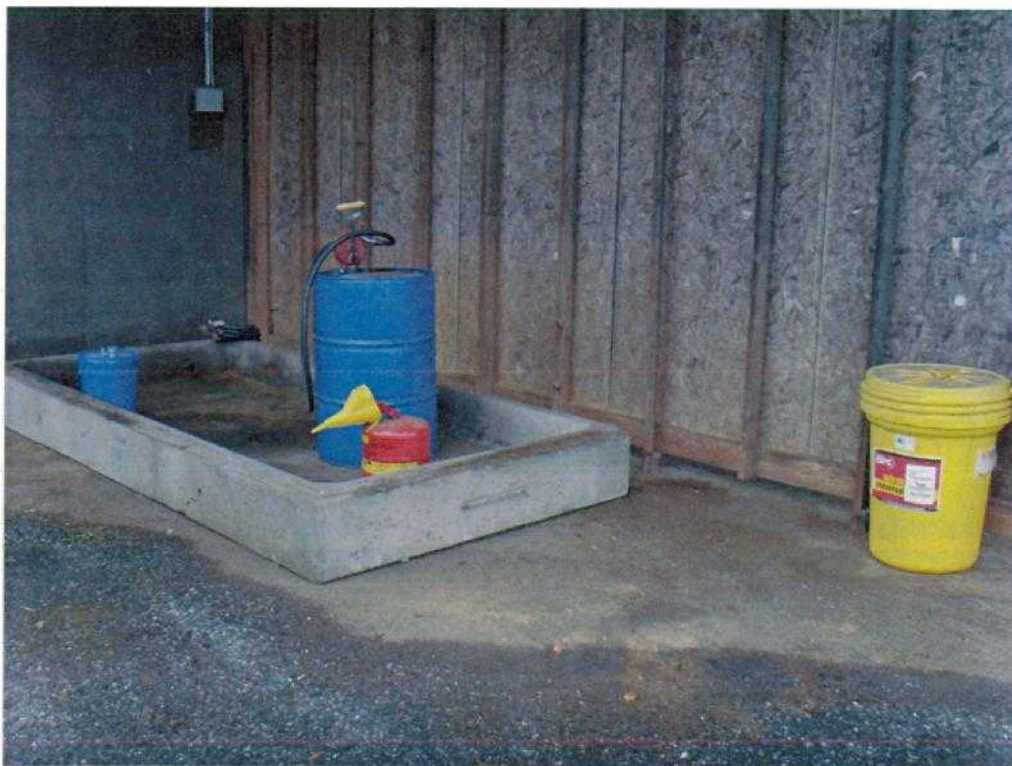
Photo 25 (SI850509): 55-gallon drum of kerosene and two small fuel containers stored inside secondary containment at the miscellaneous storage building #2. Note that two spill kits were stored near-by (one in a yellow barrel is shown here).

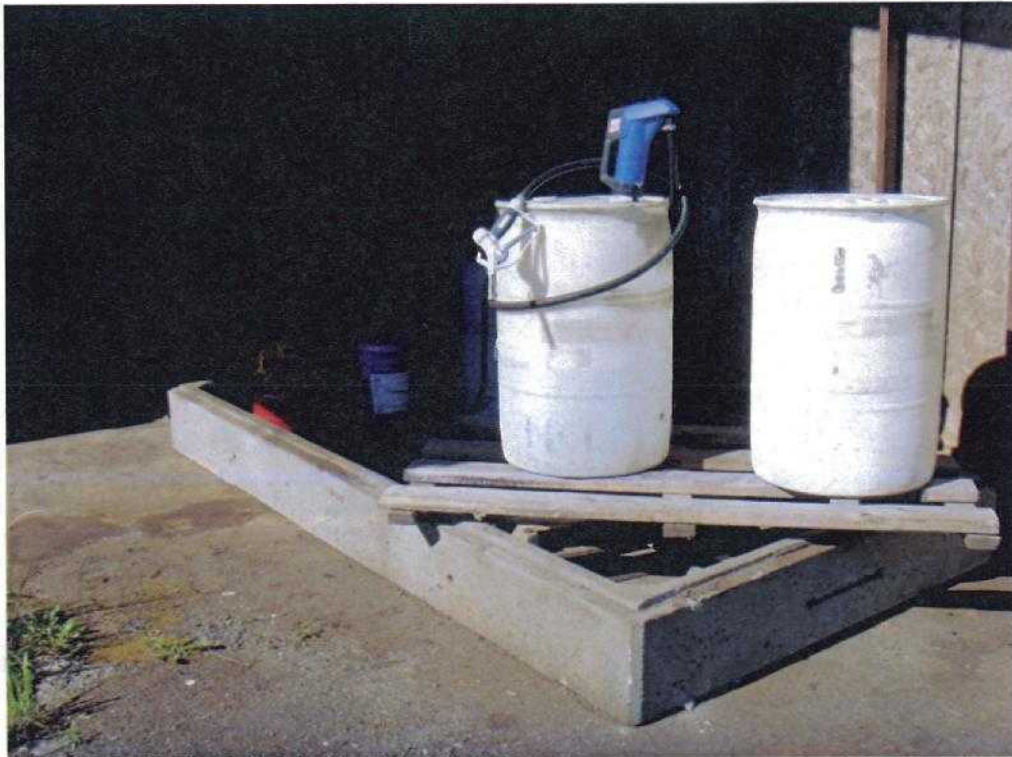
Photo 26 (SI850544): The two drums of Blue Def were stored on top of the secondary containment at the miscellaneous storage building #2 at the time of the 5/10/16 inspection.
